ENSV Inspection Transmittal Summary Report

Inspection Type:
CEI

Inspection Date:
06/16/2015

Facility Name:
Recycletronics

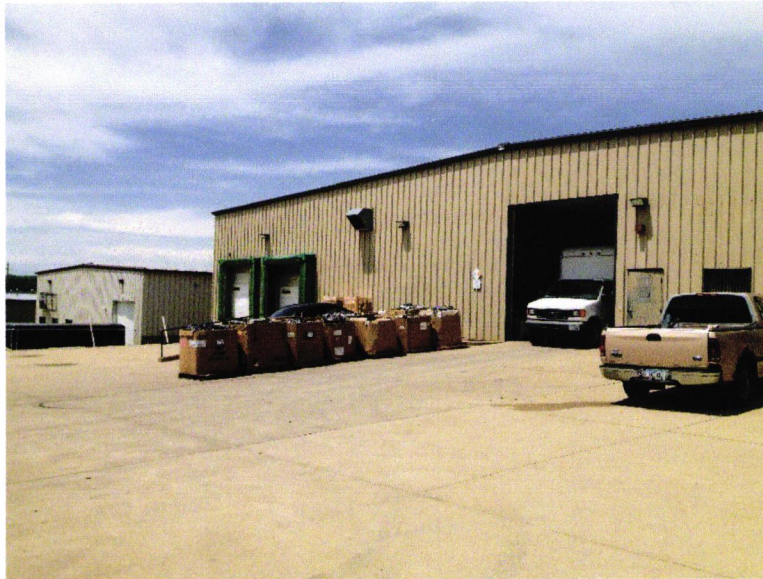
RCRA Enforcement and Permitting Assistance (REPA) Zone 3 Task Order 020	DESCRIPTION	This photograph shows the building, looking northwest.	1
	CLIENT	U.S. Environmental Protection Agency (EPA)	Date 6/16/15
	PHOTOGRAPHER	Heather Wood

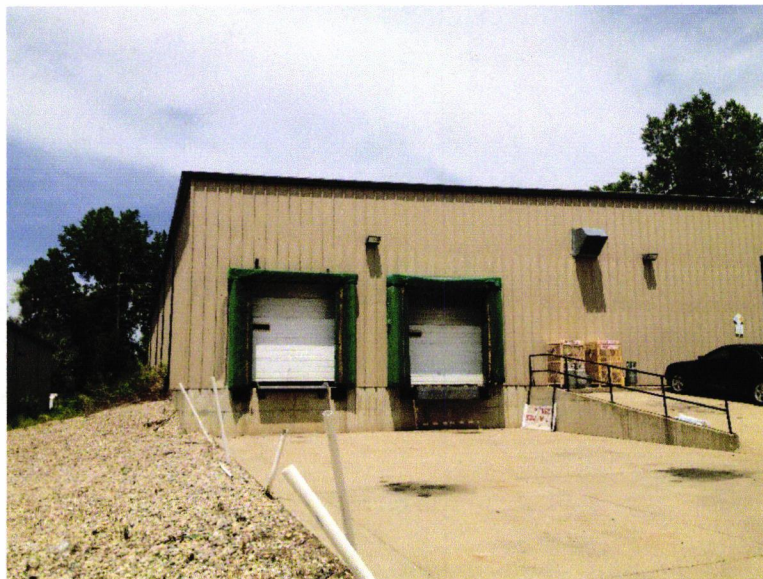
REPA Zone 3 Task Order 020	DESCRIPTION	This photograph shows the building, looking north.	2
	CLIENT	U.S. EPA	Date 6/16/15
	PHOTOGRAPHER	Heather Wood

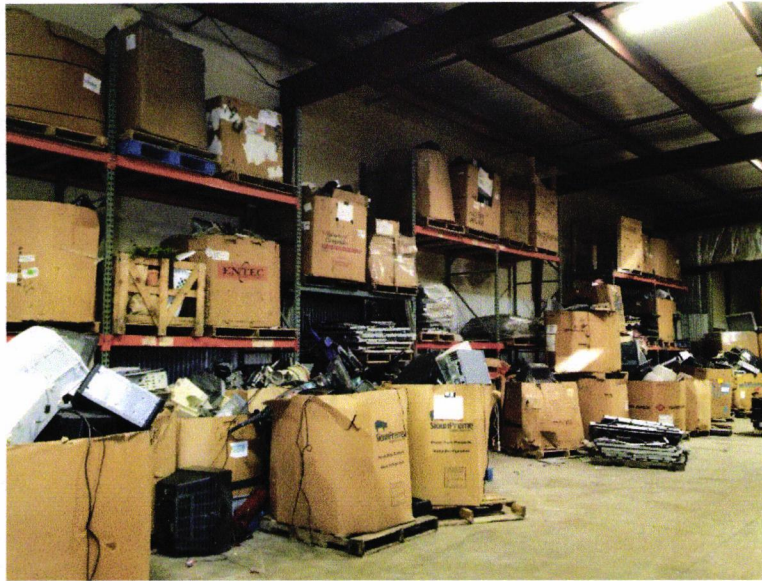
According to Mr. Rochester, under normal conditions, the equipment would be stored in the warehouse until it could be processed (see Attachment 8, Photographs 3 through 5). Inside the warehouse, I observed approximately 200 1-cubic-yard cardboard containers of equipment awaiting processing (see Attachment 8, Photograph 6). Mr. Rochester said that these containers had arrived for processing within the previous 30 days.

REPA Zone 3 Task Order 020	DESCRIPTION	This photograph shows containers of electronic equipment inside the warehouse awaiting sorting and processing.	3
	CLIENT	U.S. EPA	Date 6/16/15
	PHOTOGRAPHER	Heather Wood

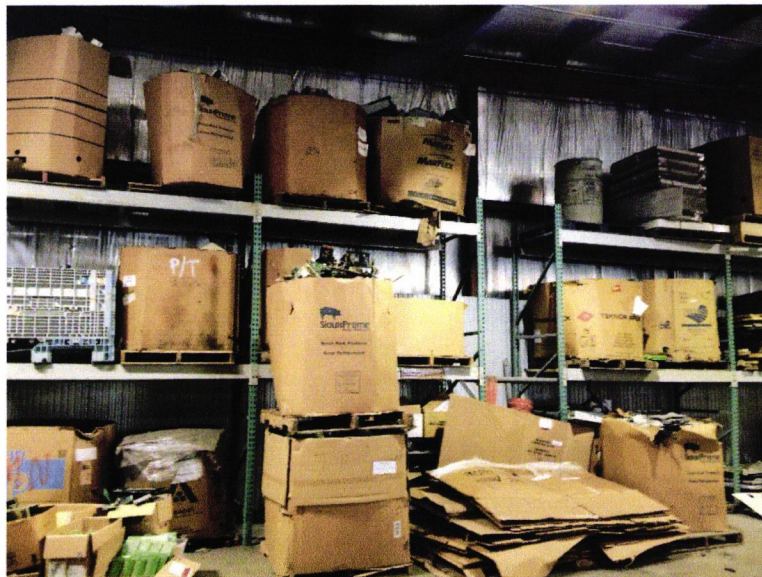
REPA Zone 3 Task Order 020	DESCRIPTION	This photograph shows containers of electronic equipment inside the warehouse awaiting sorting and processing.	4
	CLIENT	U.S. EPA	Date 6/16/15
	PHOTOGRAPHER	Heather Wood

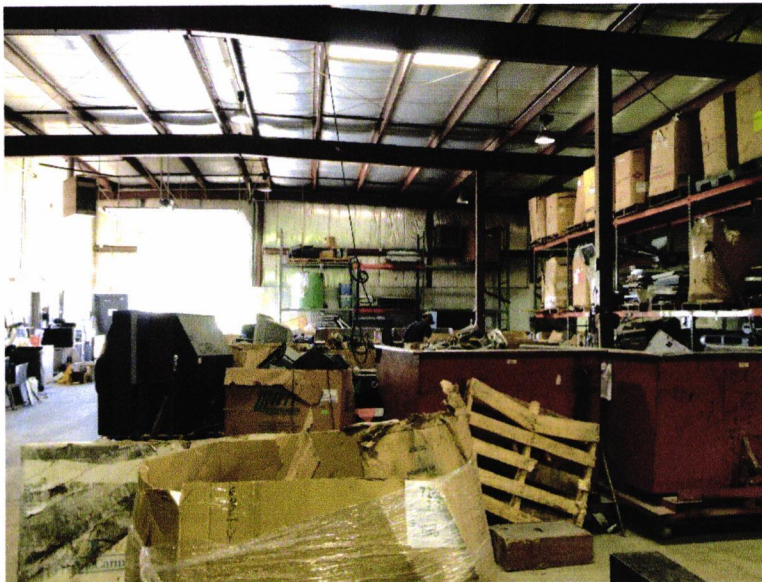
REPA Zone 3 Task Order 020	DESCRIPTION	This photograph shows containers of electronic equipment inside the warehouse awaiting sorting and processing.	5
	CLIENT	U.S. EPA	Date 6/16/15
	PHOTOGRAPHER	Heather Wood

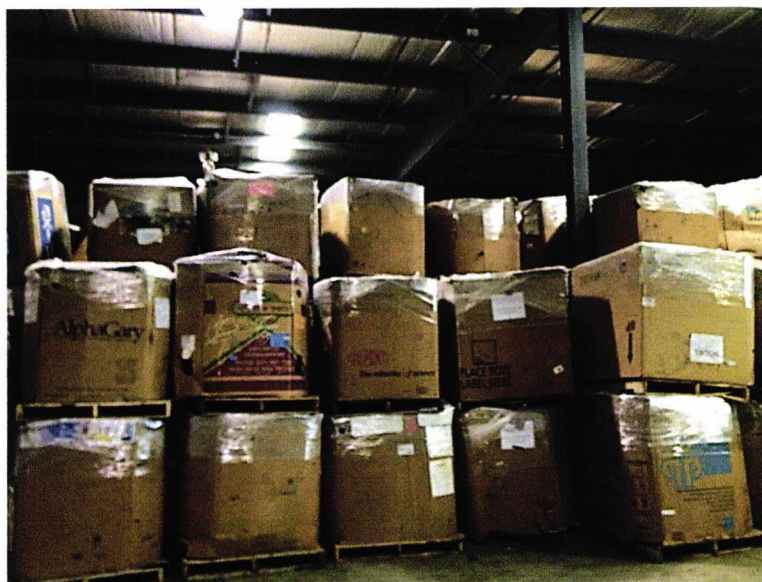
REPA Zone 3 Task Order 020	DESCRIPTION	This photograph shows containers of electronic equipment inside the warehouse awaiting sorting and processing.	6
	CLIENT	U.S. EPA	Date 6/16/15
	PHOTOGRAPHER	Heather Wood

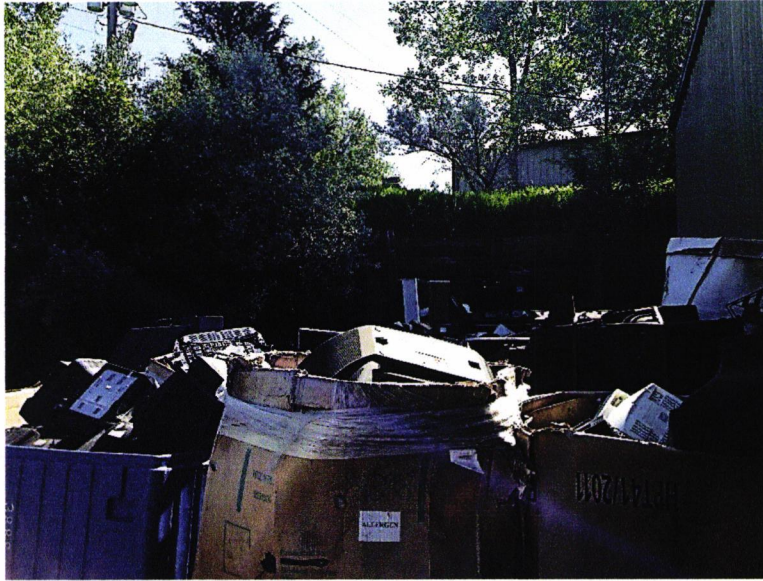
However, he said that a recent surge in deliveries within the previous 30 days had required him to stage equipment for processing behind the warehouse (see Attachment 8, Photographs 7 through 14). During my inspection, I observed approximately 30 1-cubic-yard cardboard containers outside, behind the warehouse. Some of the containers were in poor condition (see Attachment 8, Photograph 14), and I observed broken plastic and metal scrap on the concrete pad and on the unpaved ground (see Attachment 8, Photographs 15 through 18). According to Mr. Rochester, these containers had been staged outside only within the previous 30 days. However, satellite imagery from October 14, 2014, which I downloaded from Google Earth after the inspection, appears to show containers staged behind the building (see Attachment 7). I did not have the photograph at the time of the inspection, and I did not ask Mr. Rochester about the apparent containers.

During my visual inspection, I observed containers of electronic equipment awaiting processing (see Attachment 8, Photographs 7 through 14). I observed broken plastic and metal scrap outside the building on the concrete pad and on the unpaved ground (see Attachment 8, Photographs 15 through 18). I did not observe any pieces of leaded glass or broken CRTs in this area. However, because the containers were being stored outside and because some nonhazardous parts had been broken, I concluded that the facility had failed to manage the facility to minimize the possibility of a release, as required by 40 CFR 262.34(a)(4) referencing 265.31 (**NOF No. 1**). Because the facility would be an LQG if it fails to demonstrate that leaded glass debris is not speculatively accumulated, I made this finding under the requirements for an LQG. I provided compliance assistance regarding management of raw materials.

REPA Zone 3 Task Order 020	DESCRIPTION	This photograph shows containers of electronic equipment outside the warehouse awaiting sorting and processing.	7
	CLIENT	U.S. EPA	Date 6/16/15
	PHOTOGRAPHER	Heather Wood

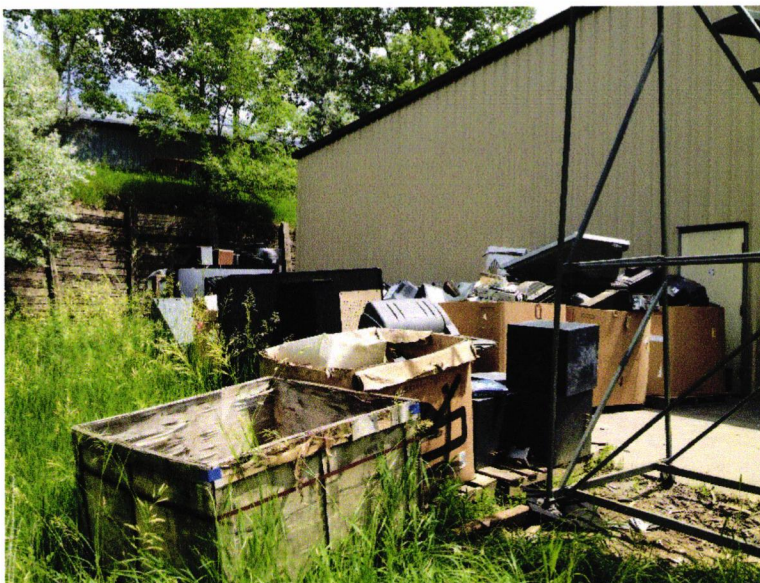
REPA Zone 3 Task Order 020	DESCRIPTION	This photograph shows containers of electronic equipment outside the warehouse awaiting sorting and processing.	9
	CLIENT	U.S. EPA	Date 6/16/15
	PHOTOGRAPHER	Heather Wood

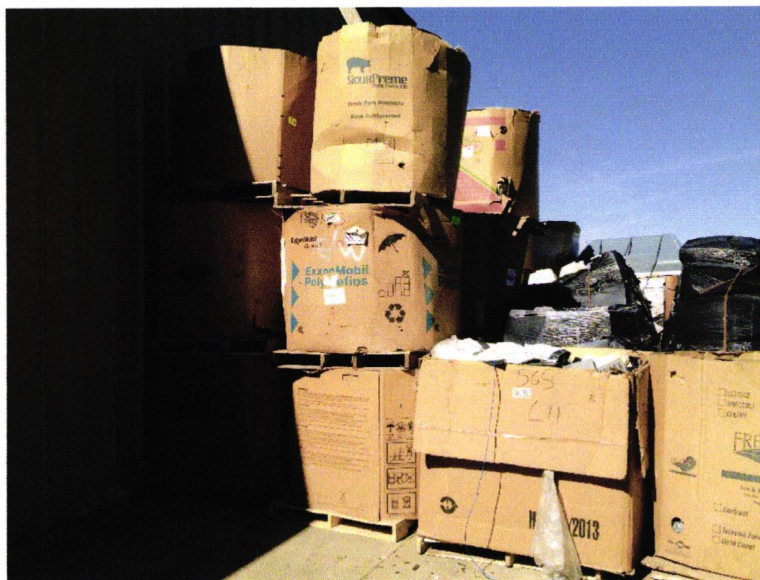
REPA Zone 3 Task Order 020	DESCRIPTION	This photograph shows containers of electronic equipment outside the warehouse awaiting sorting and processing.	10
	CLIENT	U.S. EPA	Date 6/16/15
	PHOTOGRAPHER	Heather Wood

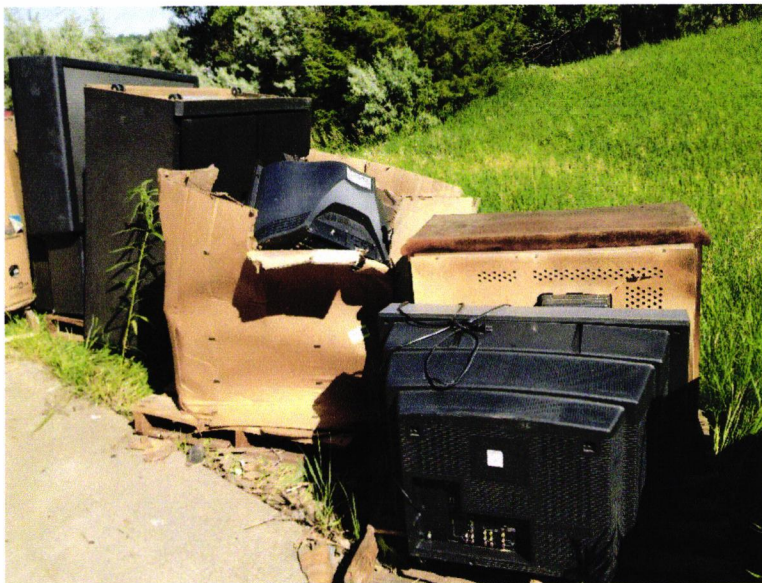
REPA Zone 3 Task Order 020	DESCRIPTION	This photograph shows containers of electronic equipment outside the warehouse awaiting sorting and processing.	11
	CLIENT	U.S. EPA	Date 6/16/15
	PHOTOGRAPHER	Heather Wood

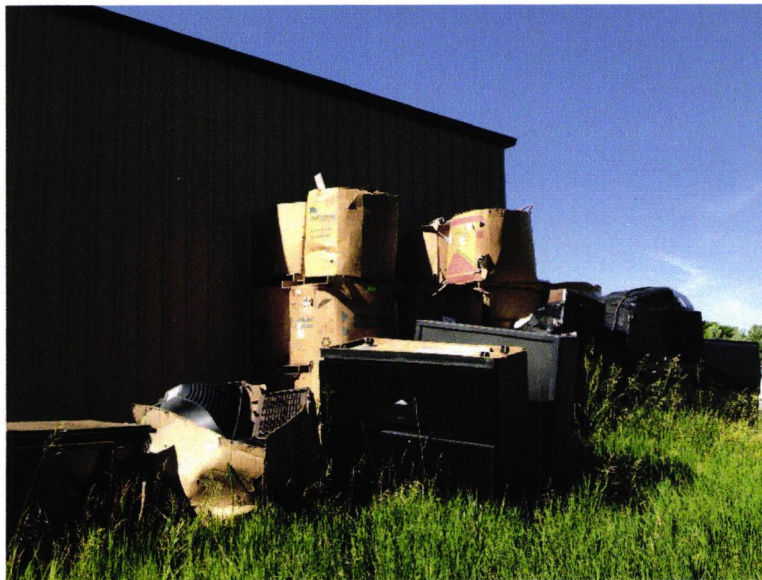
REPA Zone 3 Task Order 020	DESCRIPTION	This photograph shows containers of electronic equipment outside the warehouse awaiting sorting and processing.	12
	CLIENT	U.S. EPA	Date 6/16/15
	PHOTOGRAPHER	Heather Wood

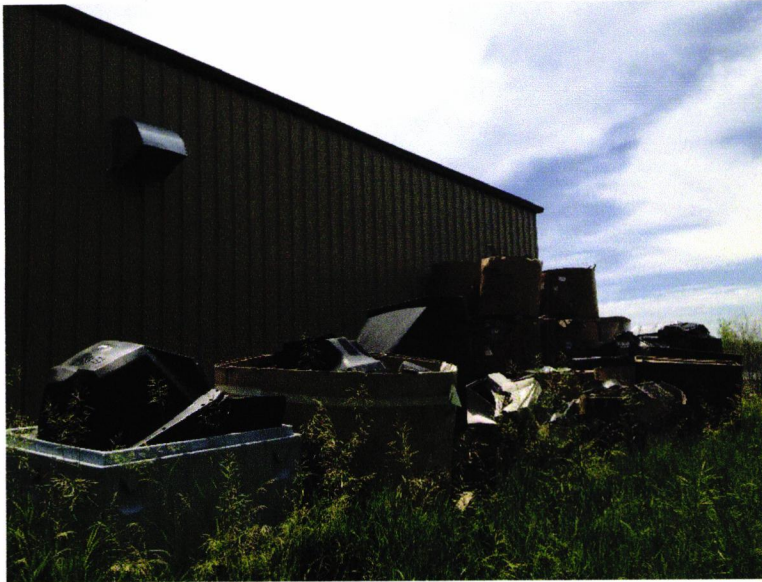
REPA Zone 3 Task Order 020	DESCRIPTION	This photograph shows containers of electronic equipment outside the warehouse awaiting sorting and processing.	13
	CLIENT	U.S. EPA	Date 6/16/15
	PHOTOGRAPHER	Heather Wood

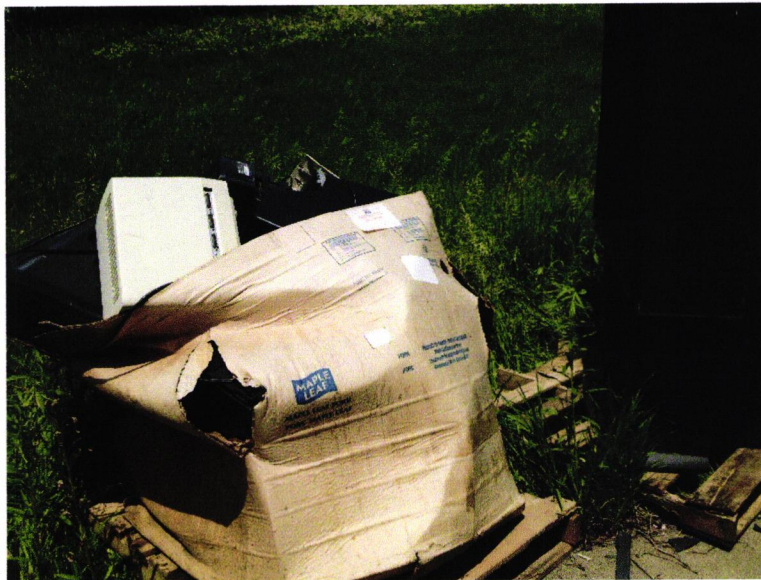
REPA Zone 3 Task Order 020	DESCRIPTION	This photograph shows containers of electronic equipment outside the warehouse awaiting sorting and processing.	14
	CLIENT	U.S. EPA	Date 6/16/15
	PHOTOGRAPHER	Heather Wood

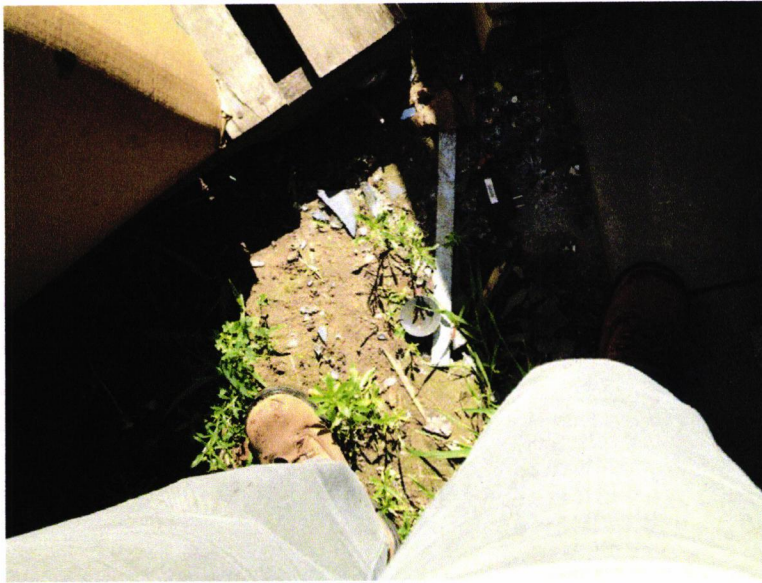
In summary, as part of the CEI, I found that the facility had failed to manage the facility to minimize possibility of a release, as required by 40 CFR 262.34(a)(4) referencing 265.31 (**NOPF No. 1**). Other than items specifically noted in the narrative, I observed no additional issues. However, further review by EPA may change or add to my findings.

REPA Zone 3 Task Order 020	DESCRIPTION	This photograph shows plastic and metal debris on the ground outside the warehouse (NOPF No. 1).	15
	CLIENT	U.S. EPA	Date
	PHOTOGRAPHER	Heather Wood	6/16/15

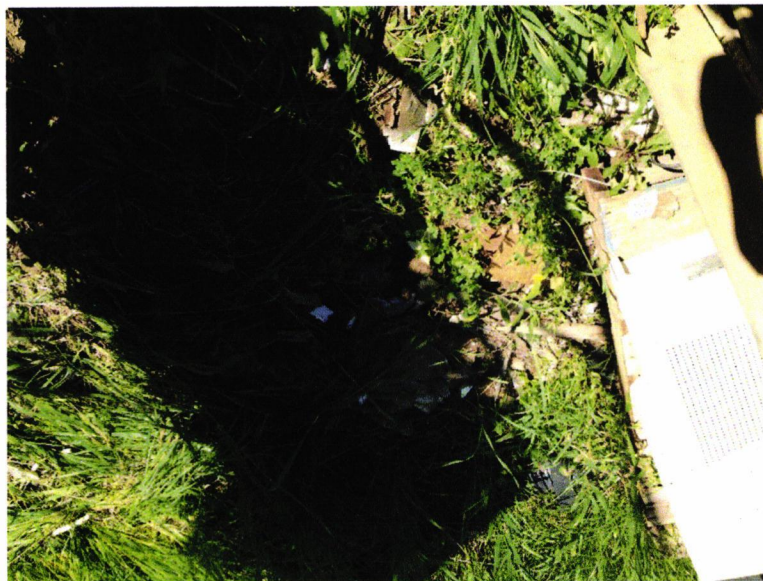
REPA Zone 3 Task Order 020	DESCRIPTION	This photograph shows plastic and metal debris on the ground outside the warehouse (NOPF No. 1).	16
	CLIENT	U.S. EPA	Date
	PHOTOGRAPHER	Heather Wood	6/16/15

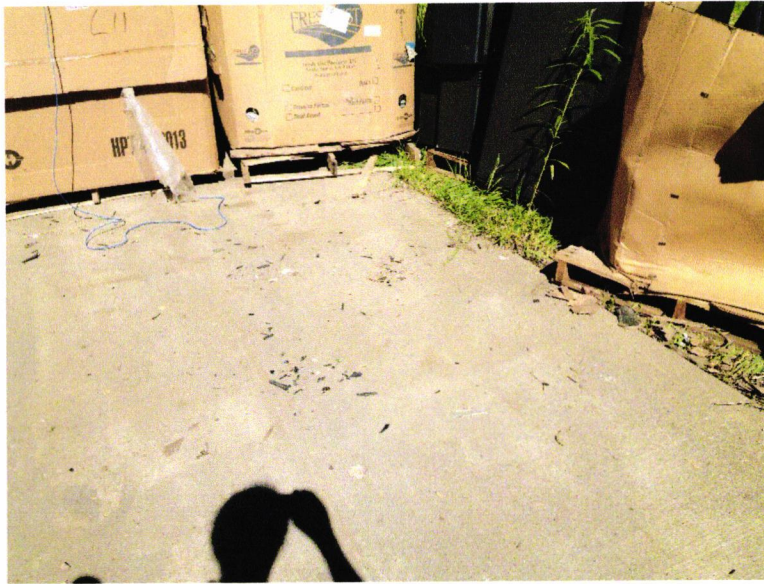
REPA Zone 3 Task Order 020	DESCRIPTION	This photograph shows plastic and metal debris on the concrete pad outside the warehouse (NOPF No. 1).	17
	CLIENT	U.S. EPA	Date
	PHOTOGRAPHER	Heather Wood	6/16/15

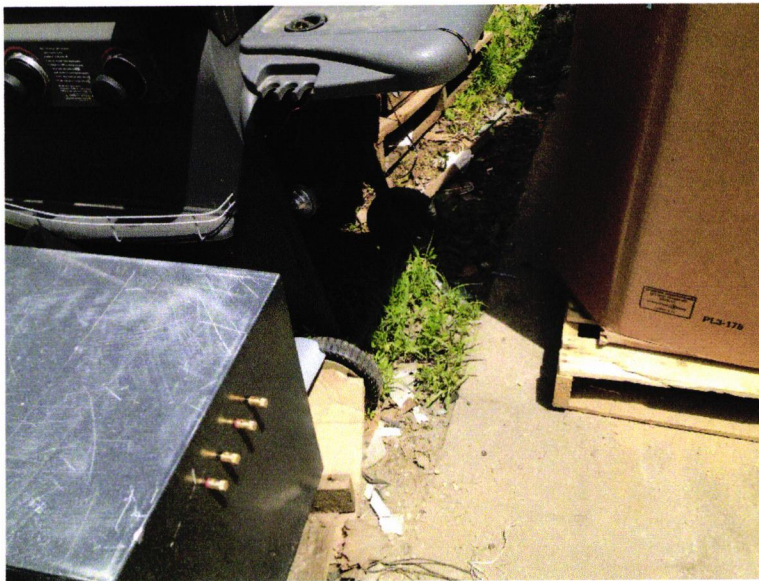
REPA Zone 3 Task Order 020	DESCRIPTION	This photograph shows plastic and metal debris on the ground and the concrete pad outside the warehouse (NOPF No. 1).	18
	CLIENT	U.S. EPA	Date
	PHOTOGRAPHER	Heather Wood	6/16/15

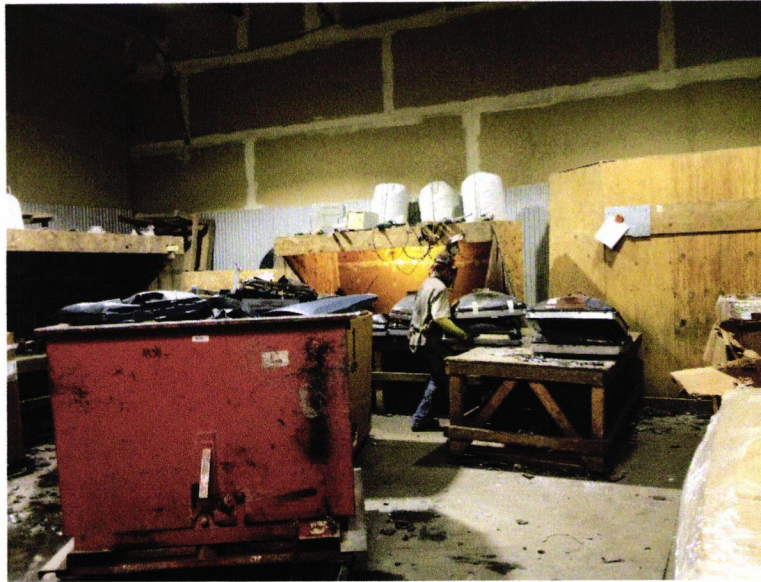
REPA Zone 3 Task Order 020	DESCRIPTION	This photograph shows the glass room, where leaded and unleaded glass cathode ray tube (CRT) components are separated.	19
	CLIENT	U.S. EPA	Date 6/16/15
	PHOTOGRAPHER	Heather Wood

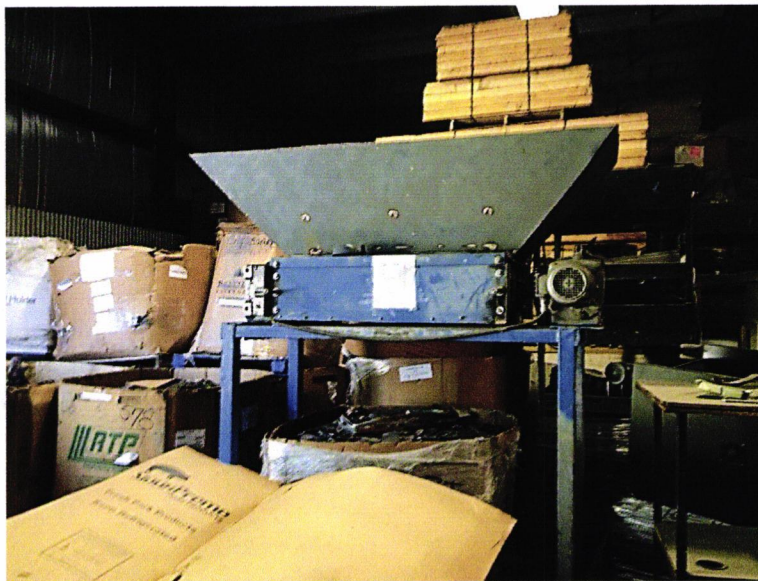
REPA Zone 3 Task Order 020	DESCRIPTION	This photograph shows a piece of glass processing equipment, no longer in use, and containers of leaded glass in the warehouse.	20
	CLIENT	U.S. EPA	Date 6/16/15
	PHOTOGRAPHER	Heather Wood

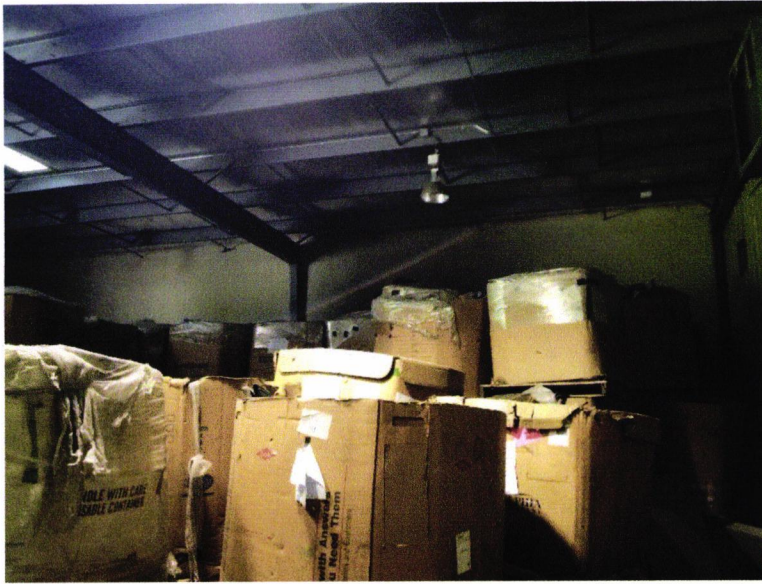
REPA Zone 3 Task Order 020	DESCRIPTION	This photograph shows containers of leaded glass in the warehouse.	21
	CLIENT	U.S. EPA	Date 6/16/15
	PHOTOGRAPHER	Heather Wood

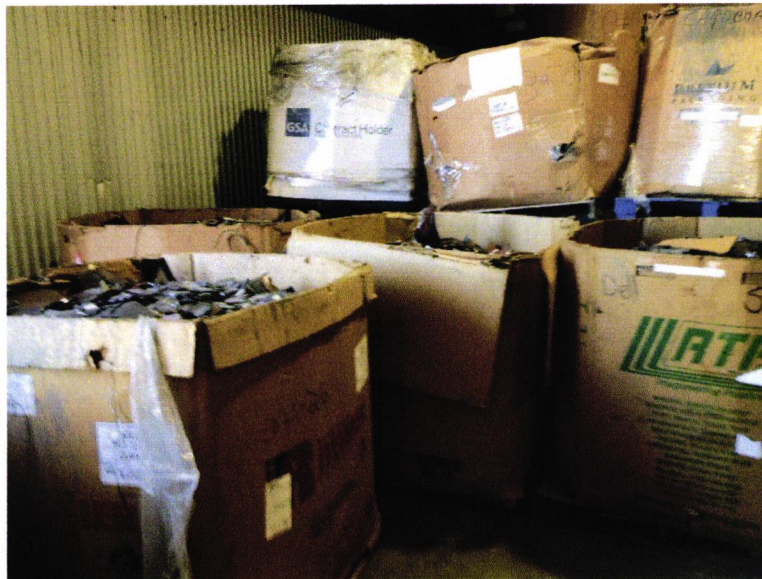
REPA Zone 3 Task Order 020	DESCRIPTION	This photograph shows containers of leaded glass in the warehouse.	22
	CLIENT	U.S. EPA	Date 6/16/15
	PHOTOGRAPHER	Heather Wood

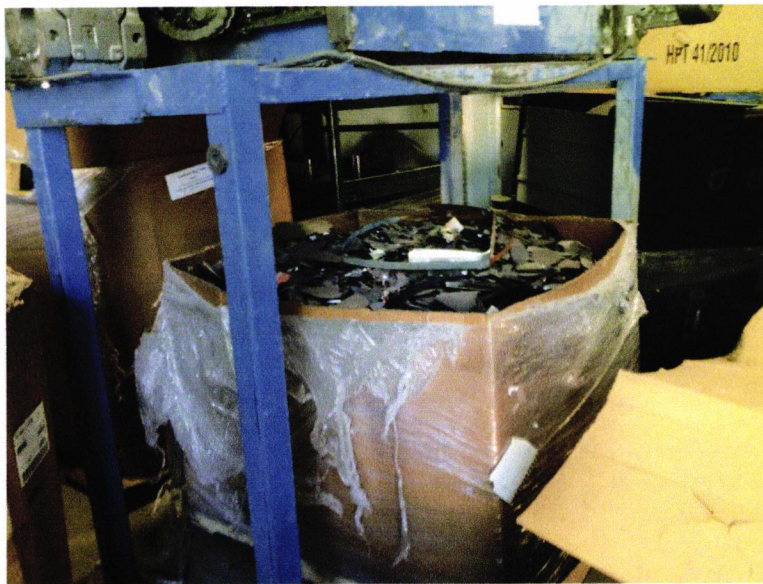
REPA Zone 3 Task Order 020	DESCRIPTION	This photograph shows containers of leaded glass in the warehouse.	23
	CLIENT	U.S. EPA	Date 6/16/15
	PHOTOGRAPHER	Heather Wood

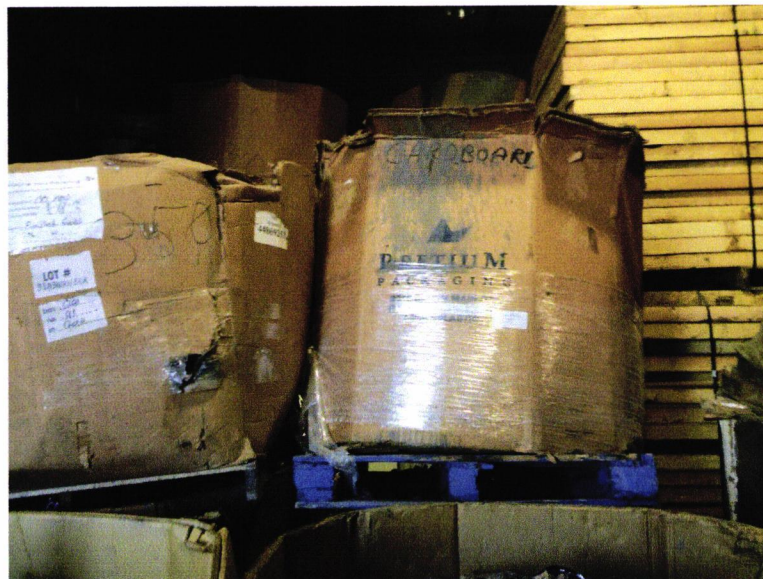
REPA Zone 3 Task Order 020	DESCRIPTION	This photograph shows containers of leaded glass in the warehouse.	24
	CLIENT	U.S. EPA	Date 6/16/15
	PHOTOGRAPHER	Heather Wood

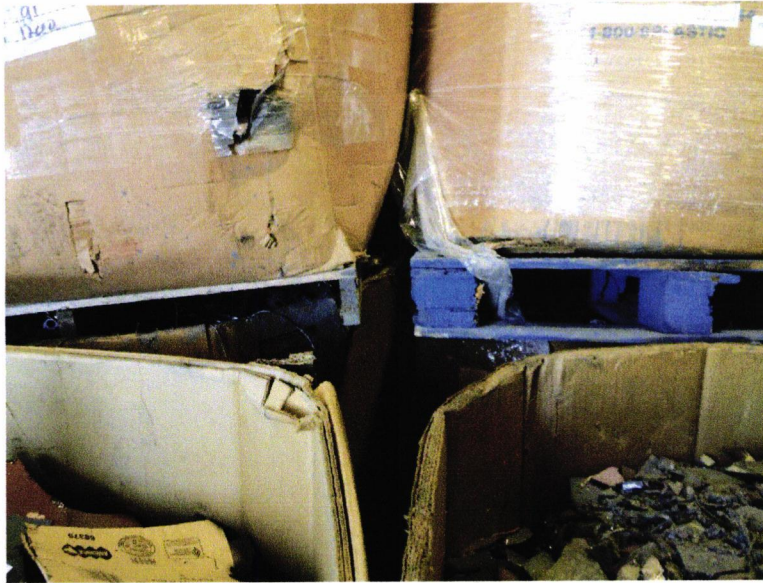
REPA Zone 3 Task Order 020	DESCRIPTION	This photograph shows containers of leaded glass in the warehouse.	25
	CLIENT	U.S. EPA	Date 6/16/15
	PHOTOGRAPHER	Heather Wood

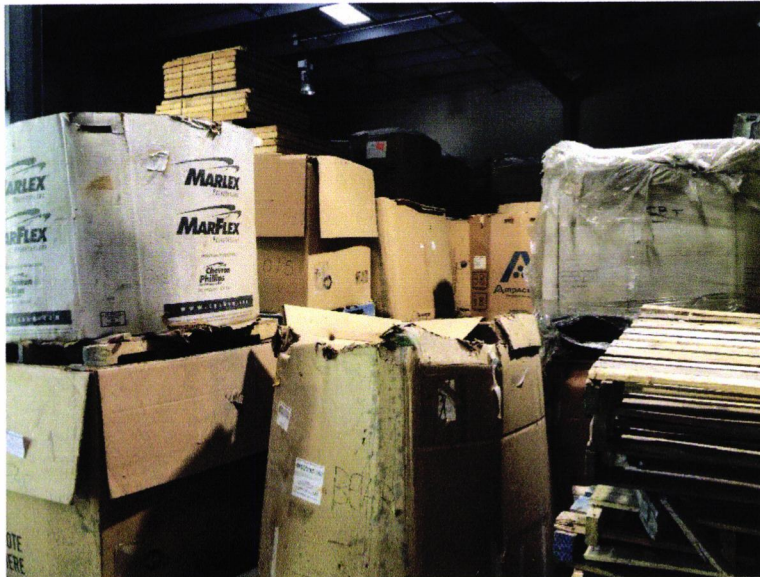
REPA Zone 3 Task Order 020	DESCRIPTION	This photograph shows containers of leaded glass in the warehouse.	26
	CLIENT	U.S. EPA	Date 6/16/15
	PHOTOGRAPHER	Heather Wood

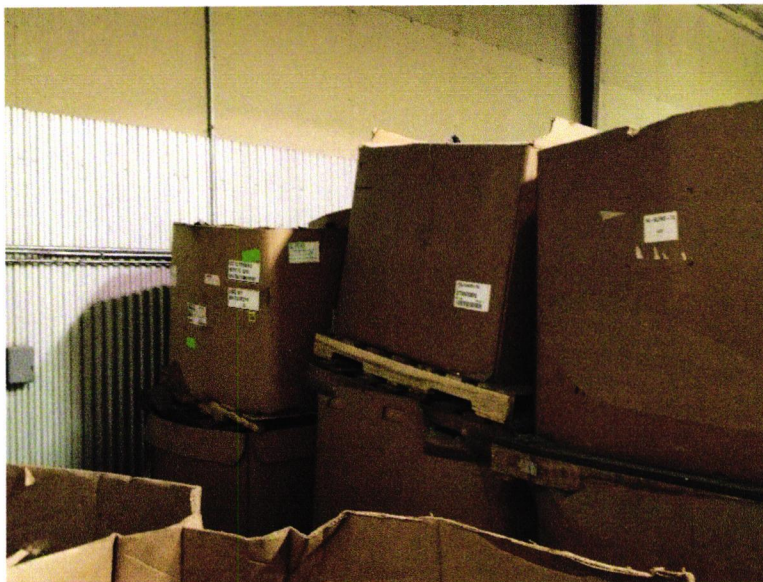
REPA Zone 3 Task Order 020	DESCRIPTION	This photograph shows containers of leaded glass in the glass room.	29
	CLIENT	U.S. EPA	Date 6/16/15
	PHOTOGRAPHER	Heather Wood

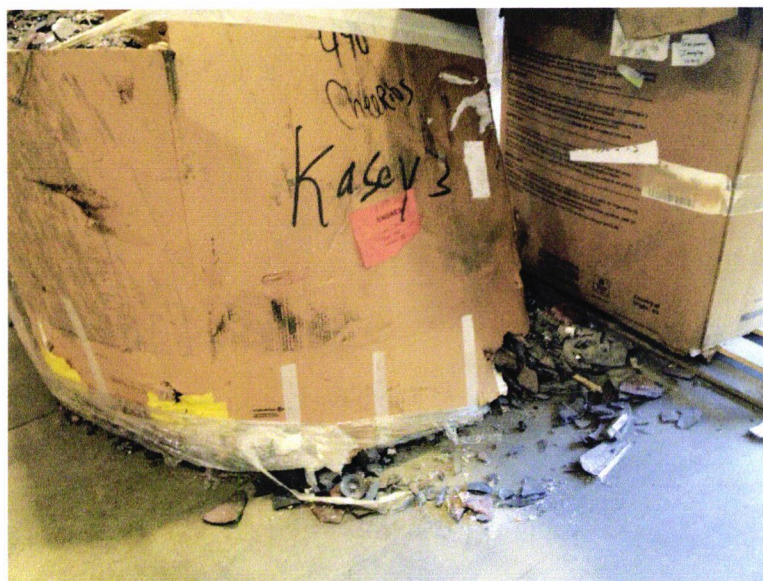
Approximately 25% of the containers were labeled as CRT glass (see Attachment 8, Photograph 27). Because of the fragility and weight of the debris and the condition of some of the containers (see Attachment 8, Photographs 30 and 31), I did not request that the facility move the containers so I could examine them further.

REPA Zone 3 Task Order 020	DESCRIPTION	This photograph shows a damaged container of leaded glass in the warehouse.	30
	CLIENT	U.S. EPA	Date 6/16/15
	PHOTOGRAPHER	Heather Wood

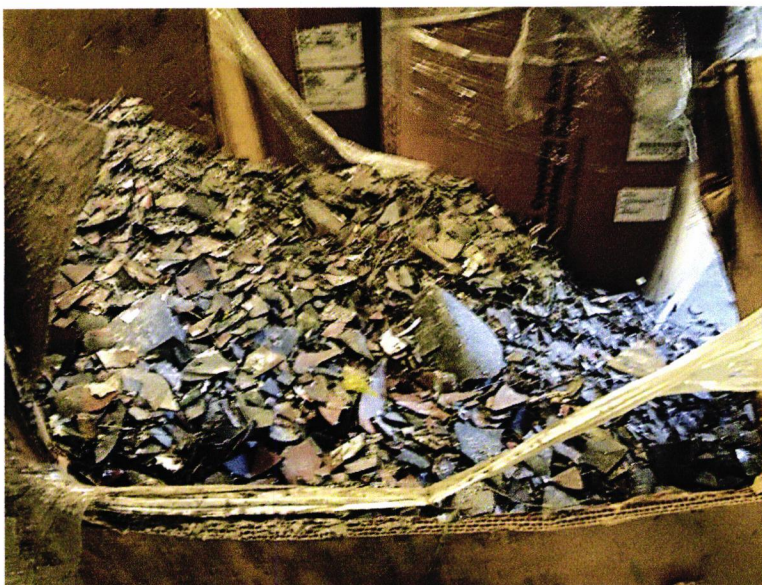
REPA Zone 3 Task Order 020	DESCRIPTION	This photograph shows the contents of the container shown in Photograph 30.	31
	CLIENT	U.S. EPA	Date 6/16/15
	PHOTOGRAPHER	Heather Wood

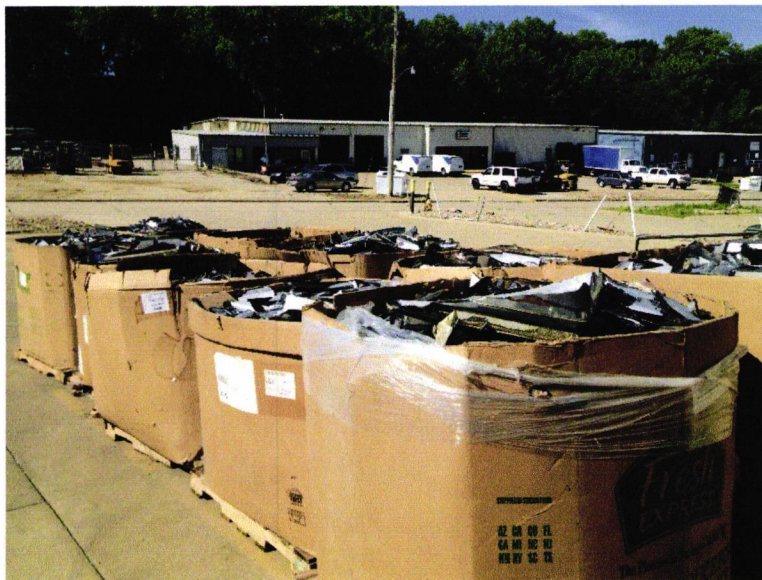
REPA Zone 3 Task Order 020	DESCRIPTION	This photograph shows containers of unleaded glass awaiting collection in front of the warehouse.	32
	CLIENT	U.S. EPA	Date 6/16/15
	PHOTOGRAPHER	Heather Wood

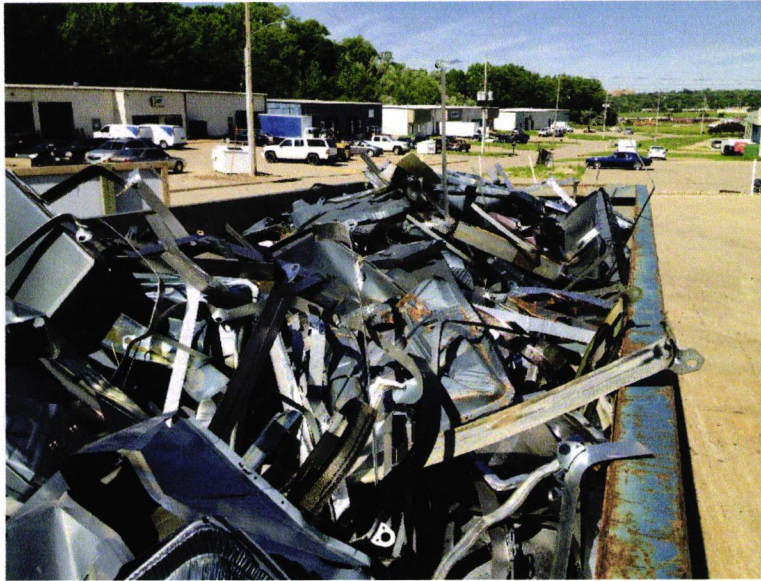
REPA Zone 3 Task Order 020	DESCRIPTION	This photograph shows a rolloff container of scrap metal in front of the warehouse.	33
	CLIENT	U.S. EPA	Date
	PHOTOGRAPHER	Heather Wood	6/16/15
